OBSERVATIONS ON A VISCOSEAL IN A TRANSPARENT HOUSING THE PREVENTION OF LEAKAGE AND BREAKDOWN

A Master's Thesis, June 1968
Chemische Werktuigen
TECHNISCHE HOGESCHOOL
Delft, The Netherlands

Fluid Sealing Research Laboratory
Mechanical and Aerospace Engineering Department
University of Tennessee

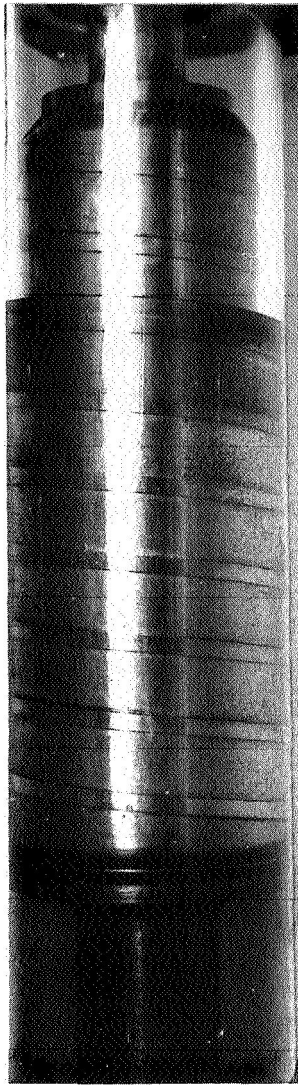
8-7

$N = 1082 \text{ rpm}$ $Re_1 = 151$

without gas ingestion

stationary immediately.

For $N = 1082$ rpm the stationary state is reached immediately after starting, pressure and level are constant (picture 8-7). For the highest number of revolutions possible, $N = 4120$ rpm, the stationary state is only reached after about 20 minutes (picture 8-33). The picture is reproducible in both cases just as the maximum pressure built up by the seal.

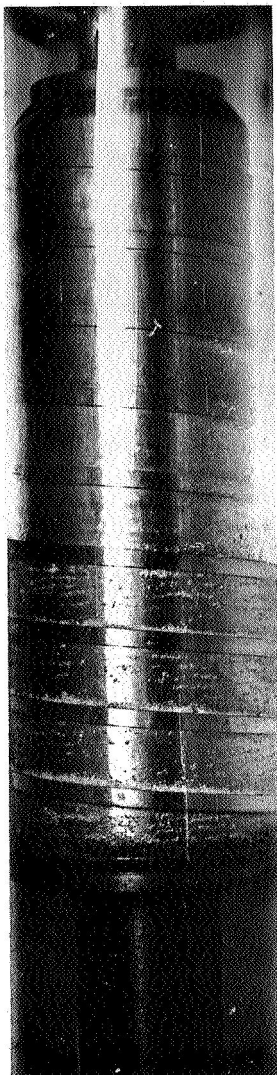
Gas inclusion and leak for $N = 1522$ rpm; $Re_1 = 212$; Fig. 8

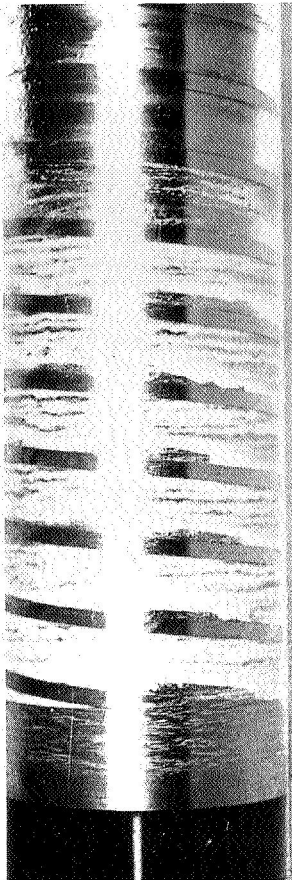
10-35

Shaft 2A; $N = 4120$ rpm. Gas appears on a large part of the closing ring but no leak occurs.
